Manhole Inspection Summary

Manhole # S13II_060MH

Location Address: **1705 POPLAR GROVE ST**

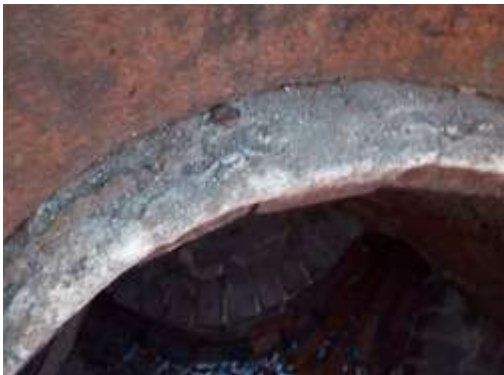
Defect 1

Offset: **3** (in.)

OFF SET FRAME

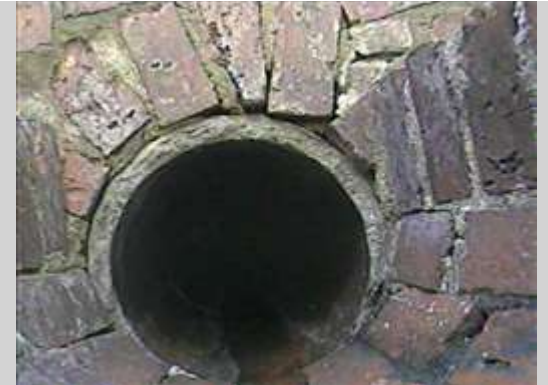
12 O'Clock Outflow

8 in. Circular Gravity Sewer
Pipe Out @ 12 O'Clock

Pipe Material: **Clay** ☐ Pipe Lined

Invert Depth: **4.55** (ft.) Flow Characteristics: **Slow**

Deposits: ☒ None ☐ Mud ☐ Sludge ☐ Debris ☐ Grease

Infiltration: **None** Pipe Seal Cond: **Sound**

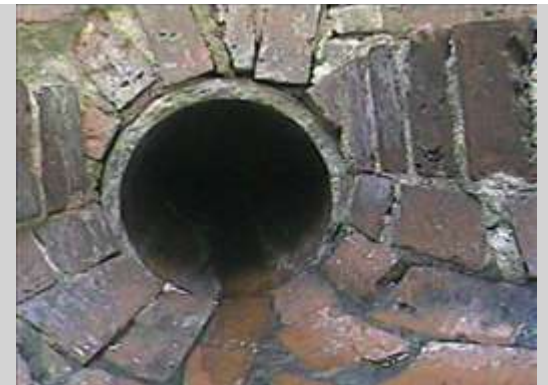
3 O'Clock Inflow

8 in. Circular Gravity Sewer
Pipe In @ 3 O'Clock

Pipe Material: **Clay** ☐ Pipe Lined

Invert Depth: **4.53** (ft.) Flow Characteristics: **Slow**

Deposits: ☒ None ☐ Mud ☐ Sludge ☐ Debris ☐ Grease

Infiltration: **None** Pipe Seal Cond: **Sound**

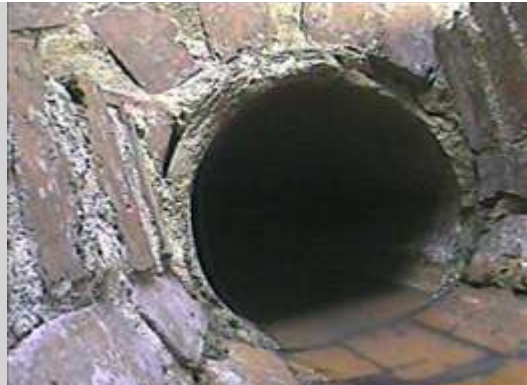
6 O'Clock Inflow

8 in. Circular Gravity Sewer

Pipe In @ 6 O'Clock

Pipe Material: **Clay** ☐ Pipe Lined

Invert Depth: **4.30** (ft.) Flow Characteristics: **Slow**

Deposits: ☒ None ☐ Mud ☐ Sludge ☐ Debris ☐ Grease

Infiltration: **None** Pipe Seal Cond: **Sound**

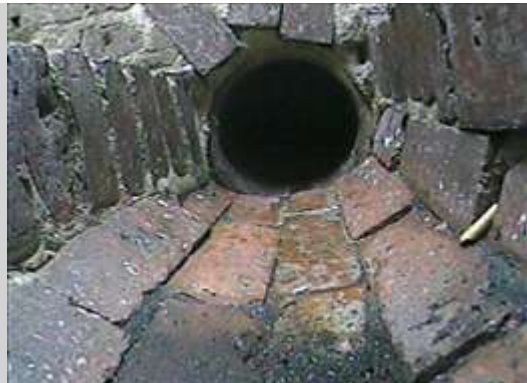
9 O'Clock Inflow

8 in. Circular Gravity Sewer

Pipe In @ 9 O'Clock

Pipe Material: **Clay** ☐ Pipe Lined

Invert Depth: **4.45** (ft.) Flow Characteristics: **Slow**

Deposits: ☒ None ☐ Mud ☐ Sludge ☐ Debris ☐ Grease

Infiltration: **None** Pipe Seal Cond: **Sound**
